FHWA/LTPP Monitoring Program

Evaluation of Pavement Performance

Forensic Study for Specific Pavement Study (SPS) Sections
390106 (SPS-1) and 390902 (SPS-9)
U.S. RT. 23 Southbound, Delaware County, Ohio

Report No. FHWA-TS-09-39-01

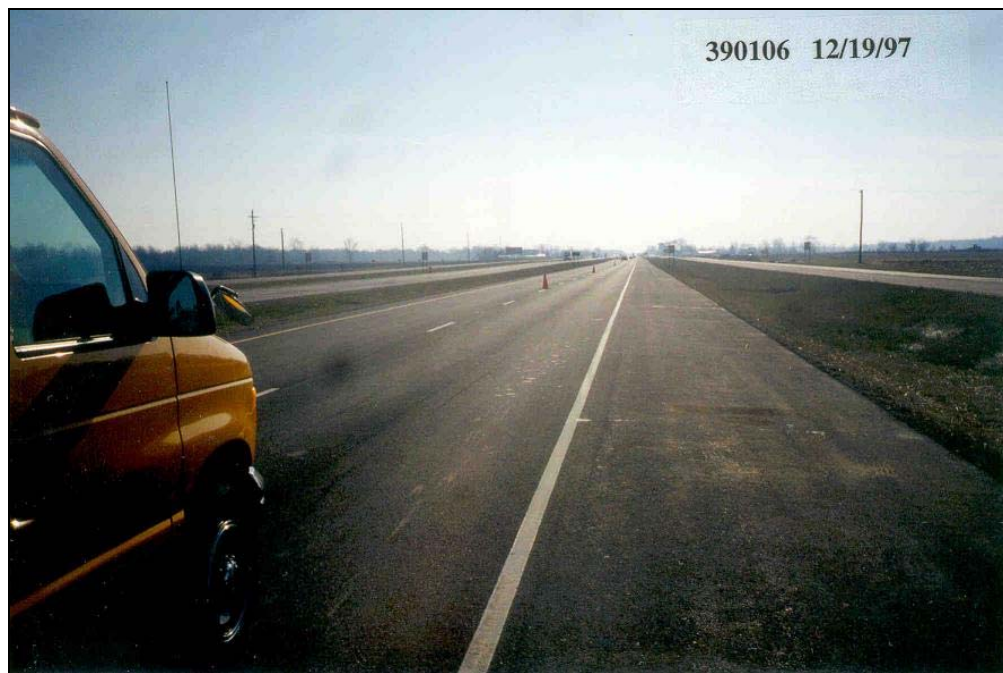
twenty-five longitudinal crack sites in Colorado, 72% were top-down cracking and 67% of the top-down cracking was associated with visual segregation at the bottom of the surface layer. A relatively large portion of coarse aggregates is distributed in the bottom half of the surface layer. The Colorado study further identified the source of the segregation. Certain models of pavers caused the early longitudinal cracking at the pavement locations corresponding to the edges of the slat conveyors and the center point of the paver. This explains the straight line longitudinal cracks shown in Figure E-3, Appendix E. A photo of the AC placement is provided in Figure E-1, Appendix E. A photo taken a year after construction shows signs of the longitudinal lines that eventually opened in to longitudinal cracks is shown in E-2, Appendix E.

Figure E-2: Photo Showing Initial Formation of Longitudinal Cracks (390106)

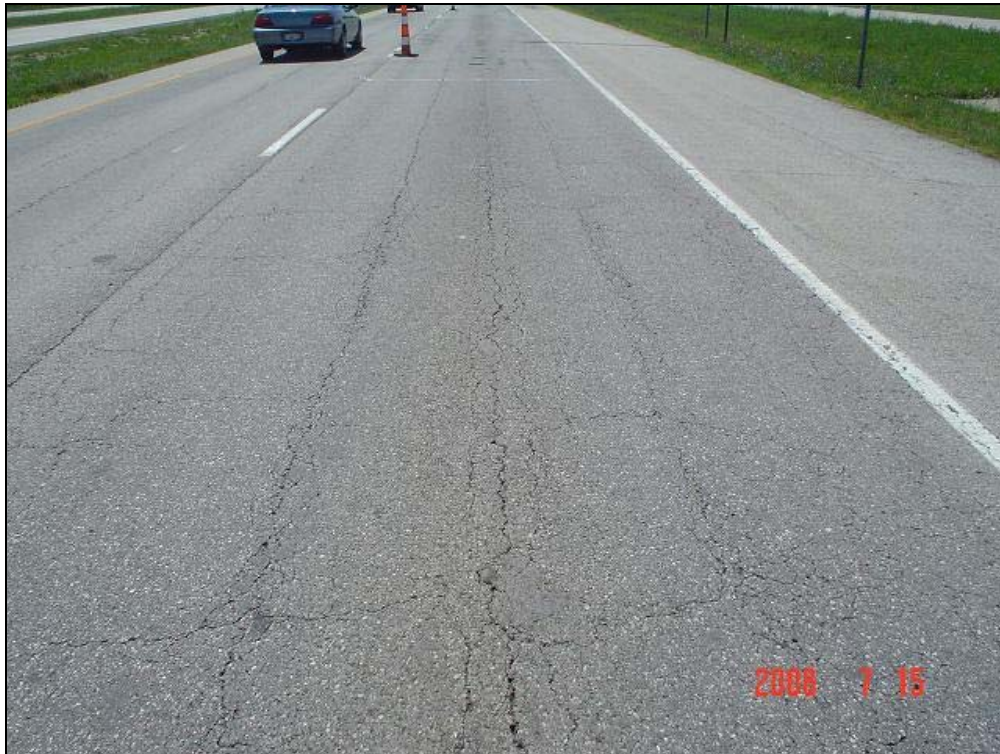
Figure E-3: Photo Depicting Types of Surface Distresses (390106)

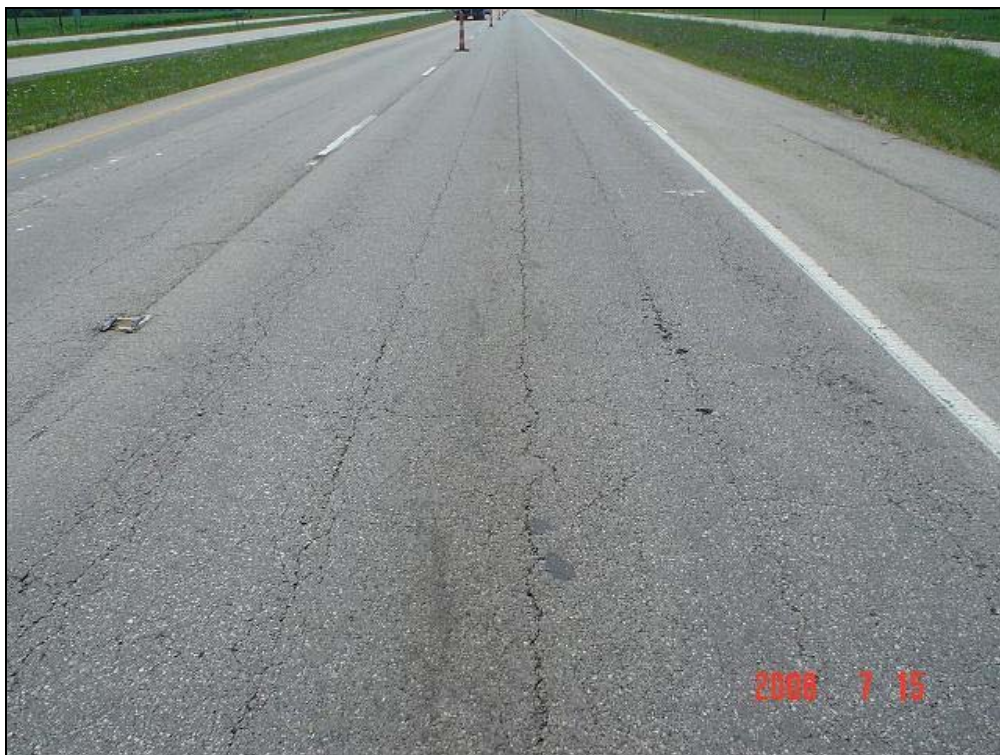
Figure E-4: Photo Showing Ravelling of Longitudinal Cracks (390106)

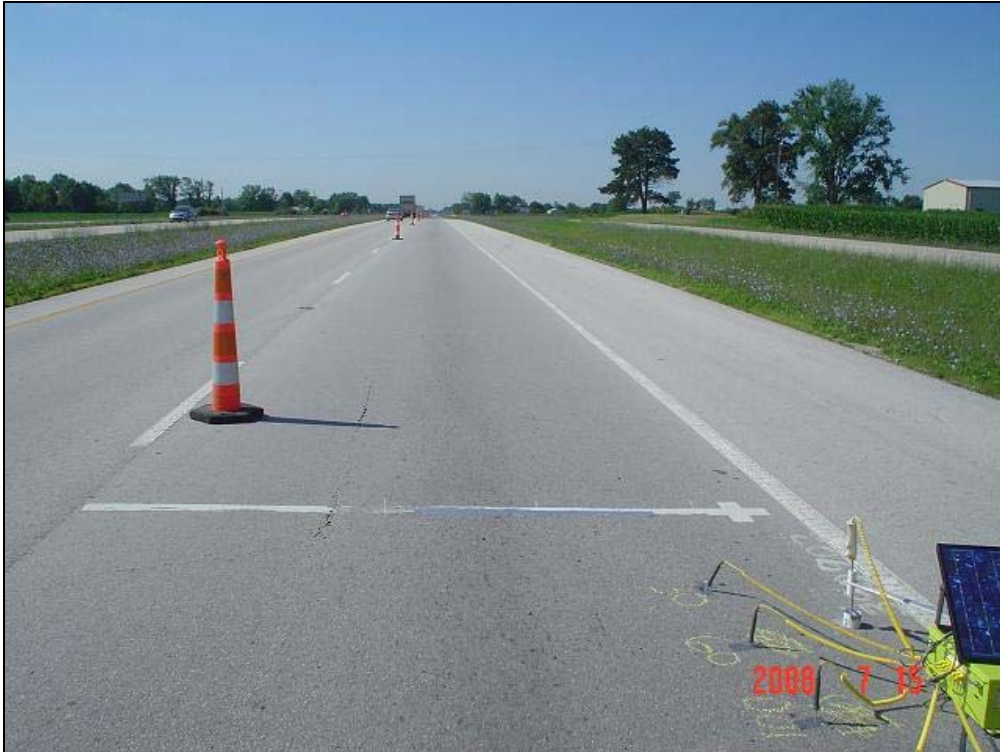
Figure E-5: Photo of Intermittent Longitudinal Crack Edge of Inner Wheelpath (390902)

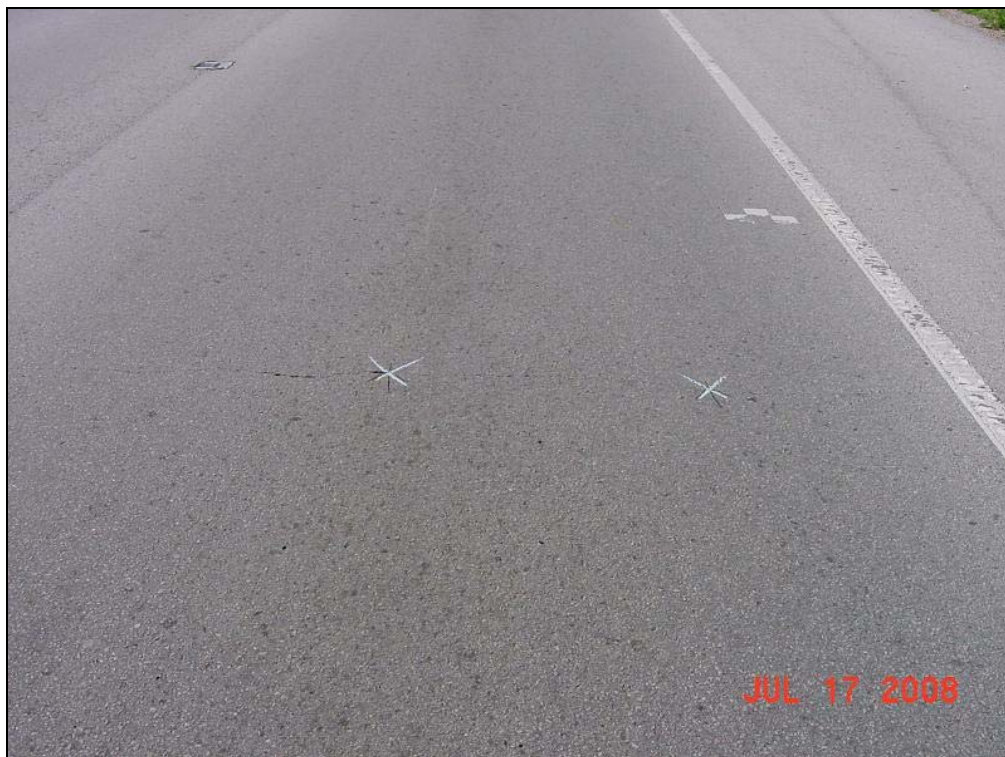
Figure E-6: Photo of Transverse Crack (390902)

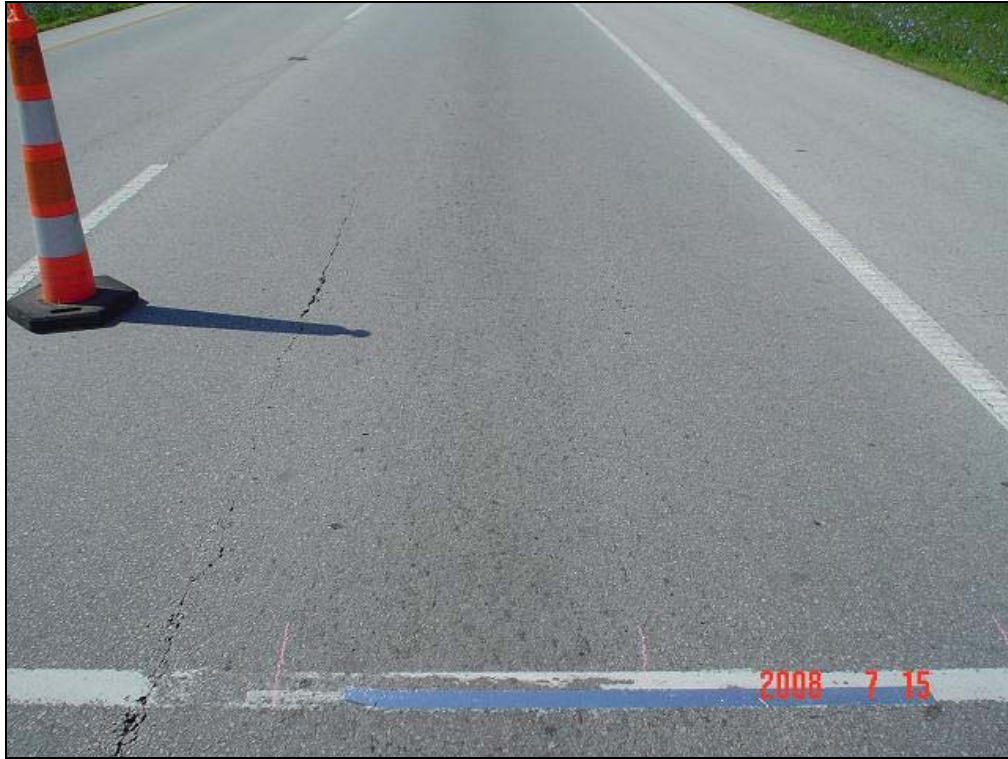
Figure E-7: Photo Showing Alligator Cracks in Inner Wheelpath (390902)

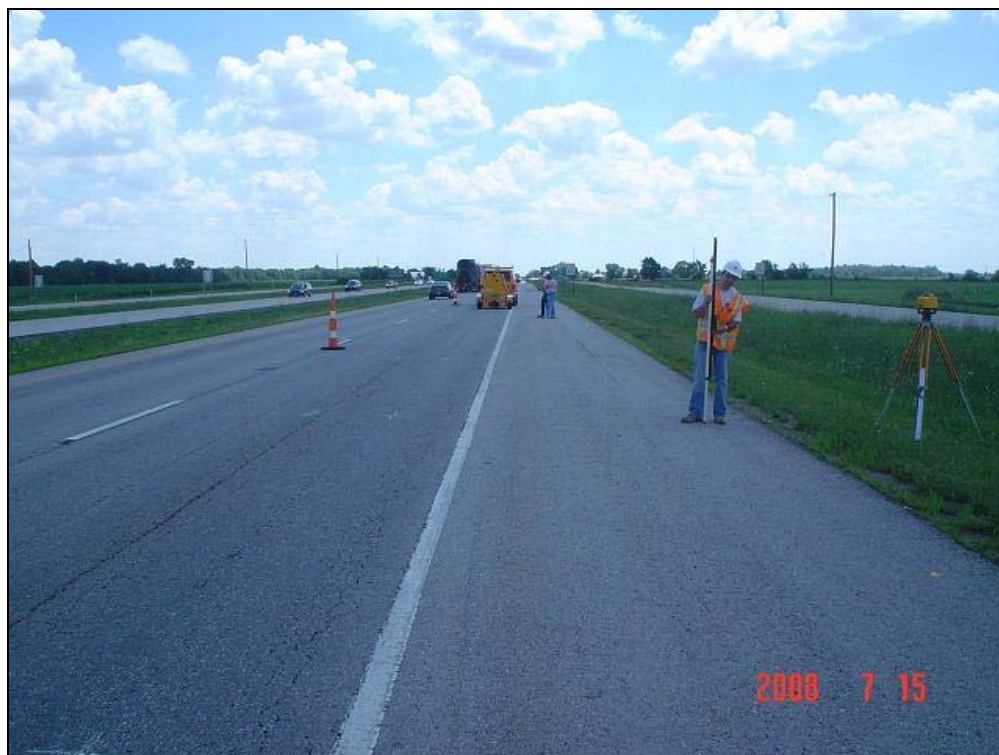
1.5% slope for the pavement and a 3.7% slope from edge to 2m on the paved shoulder. These results would indicate sufficient slope for water runoff from the pavement surface. These results are consistent with those observed during the site review and as evident in the photo provided in Figure E-10, Appendix E.

Figure E-10: Photo of Elevation Survey and Pavement Grade for 390106

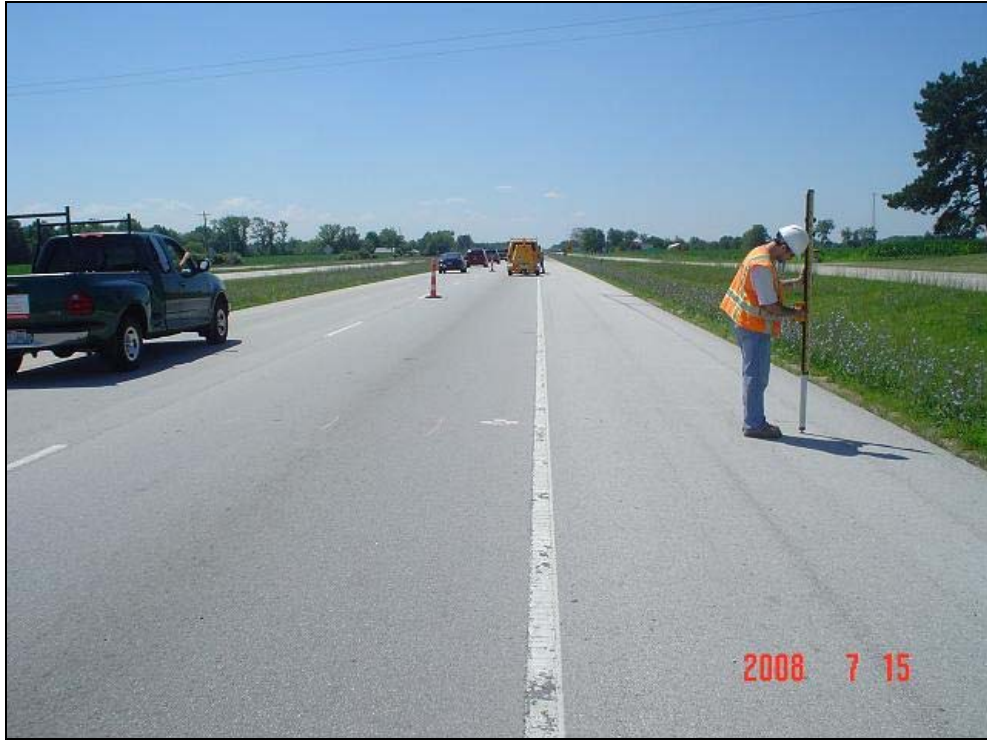
Figure 9. The results show a slight deviation in elevation at the wheelpath location with a 1.2% slope for the pavement and 3.2% slope from edge to 2m on the paved shoulder. These results would indicate sufficient slope for water runoff from the pavement surface. These results are consistent with those observed during the site review and as evident in the photo provided in Figure E-11, Appendix E.

Figure E-11: Photo of Elevation Survey and Pavement Grade for 390902

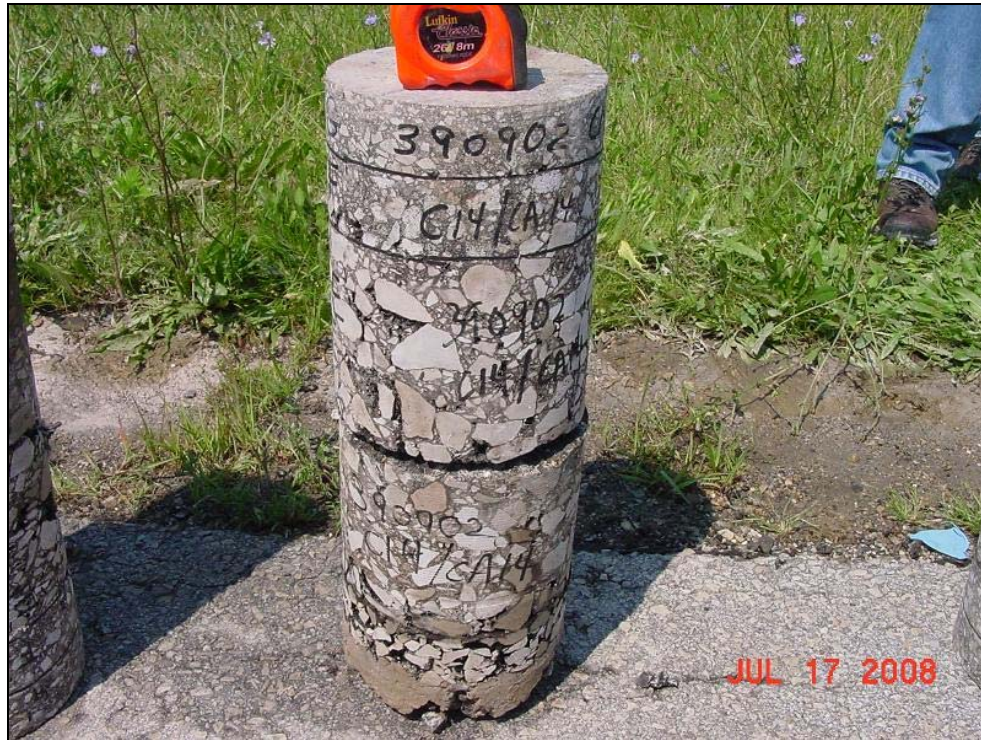
Figure F-11: Core shows bond separation between layer 2/3 of ATB

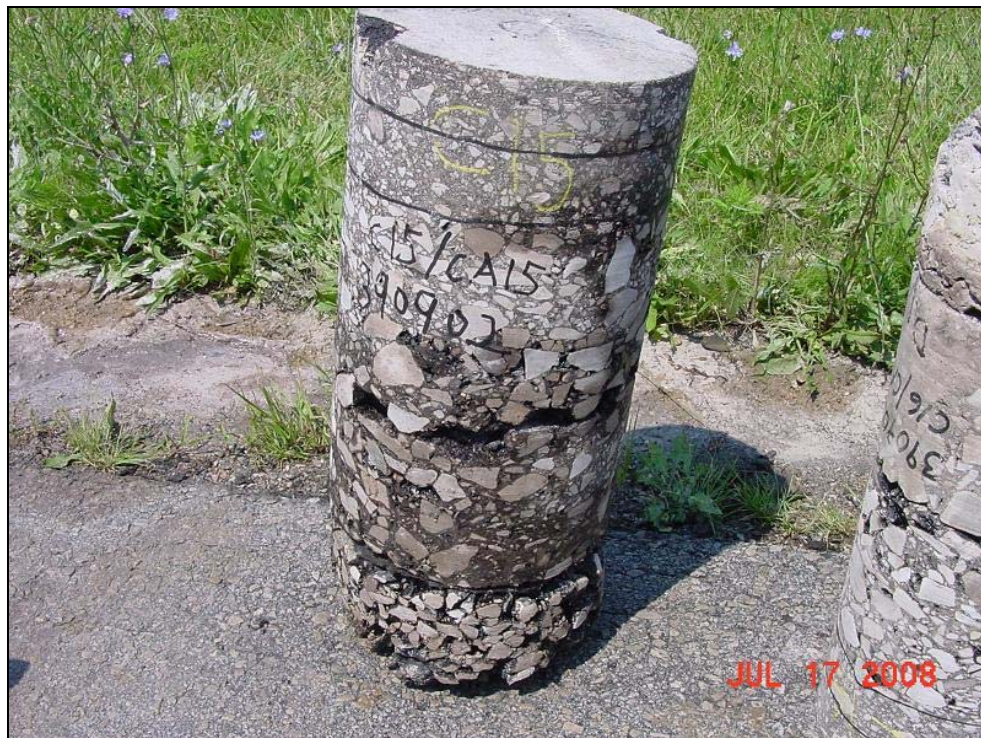
Figure F-12: Core showing layer separation and voids

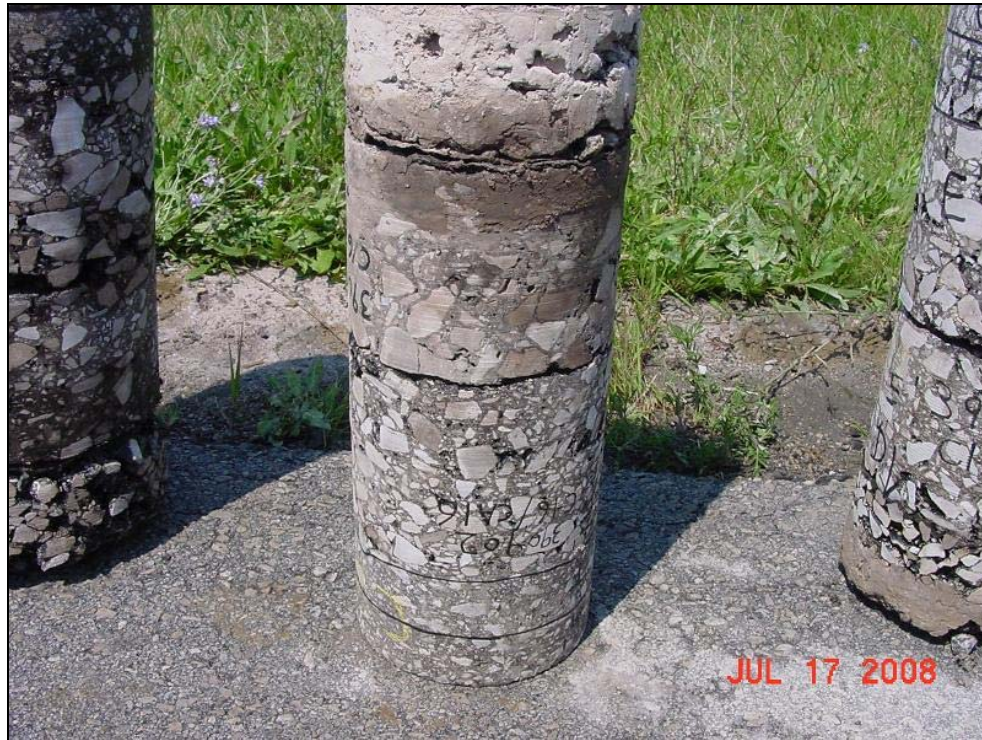
Figure F-13: Core showing geo-fabric between ATB and PATB

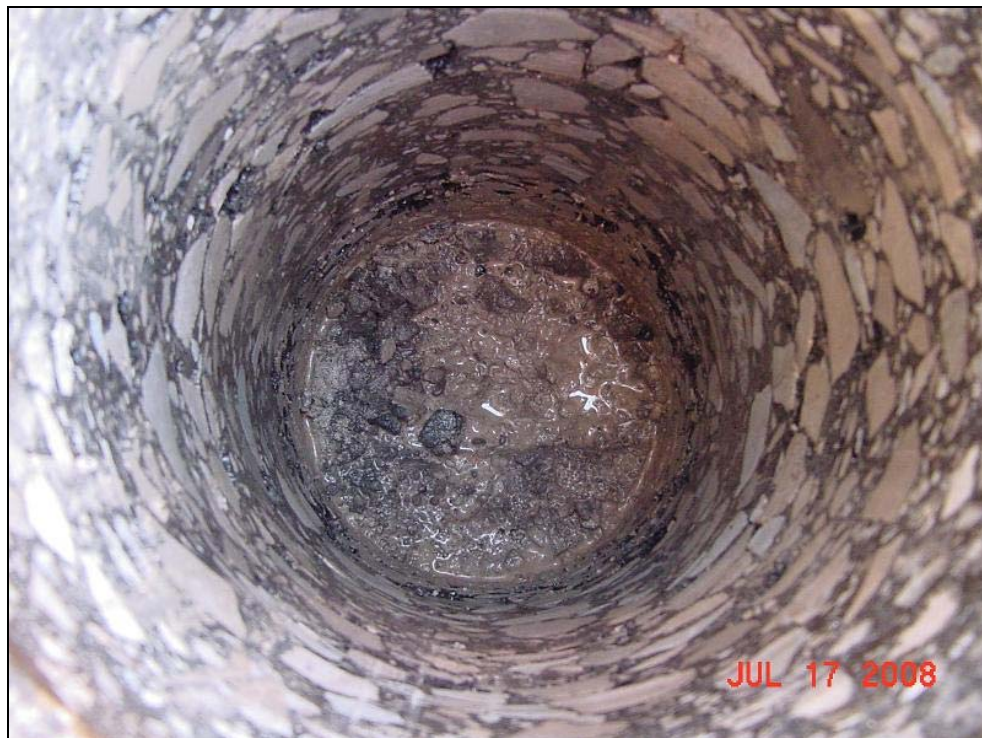
Figure F-14: Photo of core hole showing voids in ATB

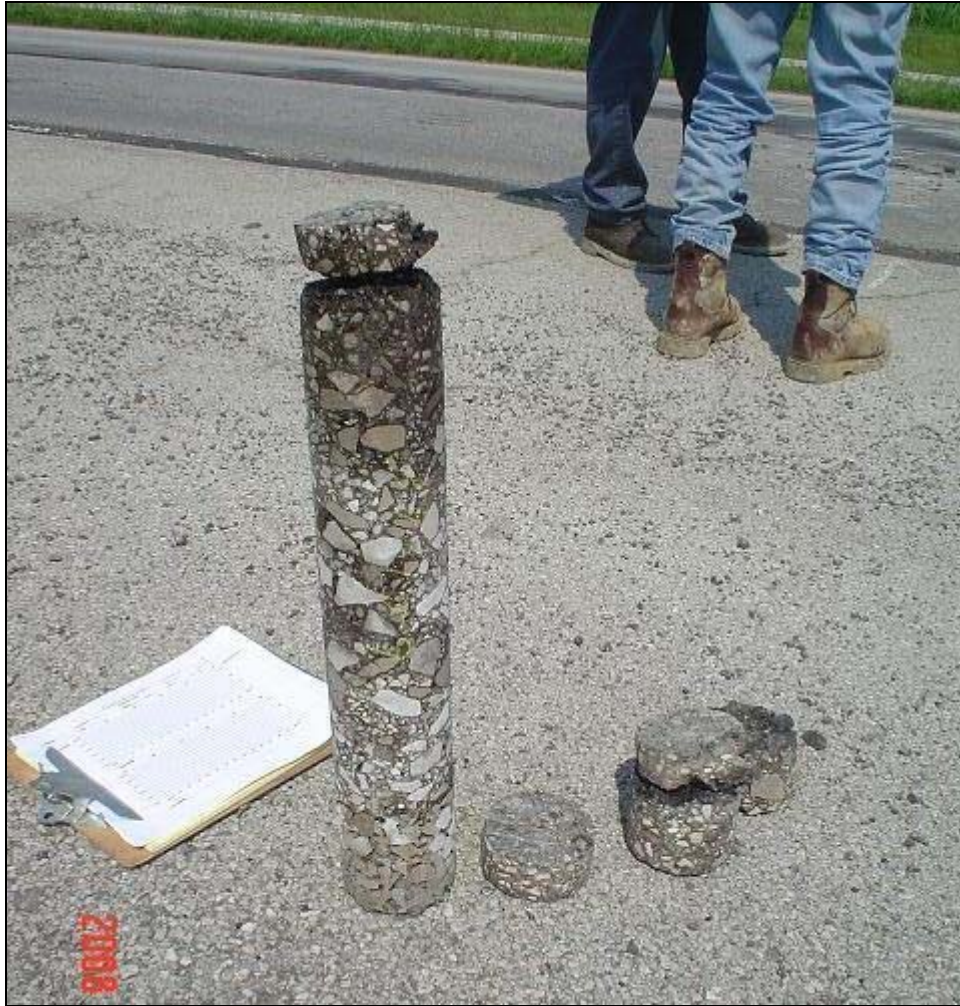
Core examination from both sections indicated that all cracking was top down with a great amount of stripping. Deterioration at the interface of the surface and AC binder lifts were visible on the cores from section 390106. The ATB from both sections had visible voids and there was some observed bonding issues between paving layers 2 and 3 of the ATB for section 390902. The interface of the AC bound layers with the aggregate base show minimal, if any, signs of stripping. The surface of 390106, which was starting to ravel, had some loose aggregate when probed with a sharp edge, whereas the surface for 390902 was firm and intact.

Figure F-15: Cores with longitudinal crack and stripping at interface to base and surface

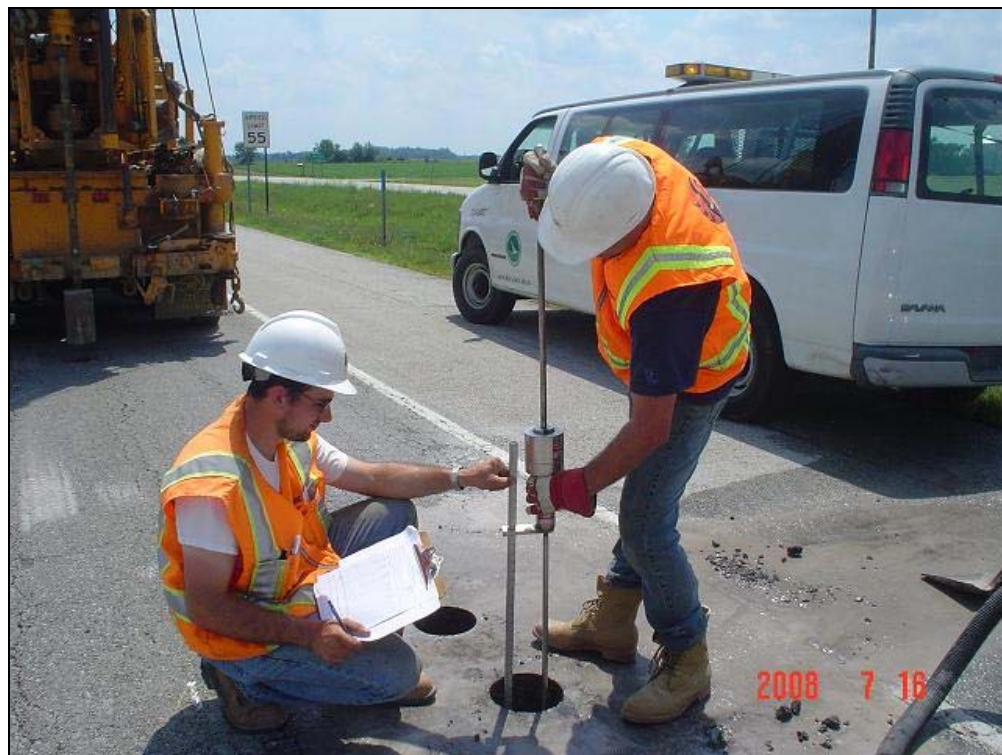
Table 7 provides the results from the DCP tests performed at the three locations selected from FWD tests in the midlane and outer wheelpath. The field moisture values were taken from the soil samples retrieved as part of the split-spoon sampling. As previously mentioned the base material was disturbed, therefore moisture samples were only available for the outer wheelpath at station 4+50 (137.2m). Although the field moistures were slightly above optimum, there were no adjustments to the DCP results; similarly there were no seasonal adjustment factors applied to the FWD results. A photo of the operators performing the DCP test is provided in Figure G-4, Appendix G. The field data sheets are provided in Appendix H.

Figure G-4: Performing the DCP test
